INSPECTION REPORT Nr LNP/BJ-12/048-CD01

PROJECT: Ghana Early Phase Gas Infrastructure Project	Ref: JPP/HF-12/048
J-PECO Client: Sinopec International Petroleum Service Company (SIPSC)	P/o nr: / (client to J-PECO)
Manufacturer: SICHUAN KEYCON VALVE MANUFACTURING CO., LTD (KCON)	P/o nr: / (client to Manufacturer)
Inspection requested by: Sinopec International Petroleum Service Company (SIPSC)

No.	SUPPLY / SUBJECT OF INSPECTION	KCON Serial Nr	Project TAG Nr	QTY
1	12"-1500LB Top Entry Trunnion Ball Valves (PNEUMATIC ACTUATOR)	J-31362-1	ESDV-01-001-GP	1 set
2	12"-1500LB Top Entry Trunnion Ball Valves (GEAR OPERATOR)	J-31361-1, J-31361-2, J-31361-3, J-31361-4.	J-PECO-01-001-GP, J-PECO-01-002-GP, J-PECO-01-003-GP, J-PECO-01-004-GP.	4 sets

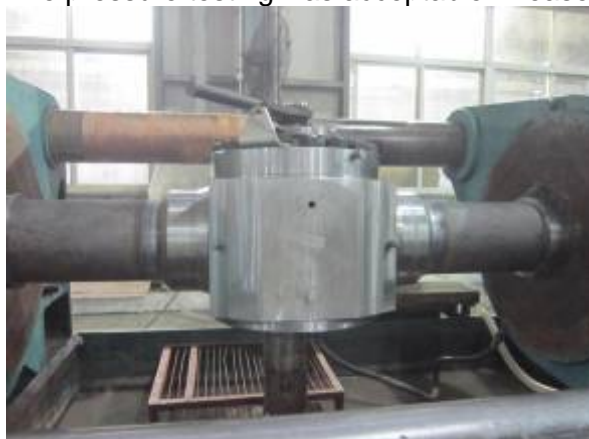
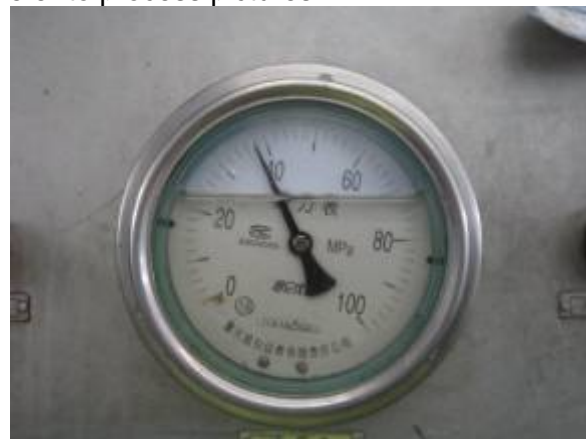
Shell strength testing

P=38MPa

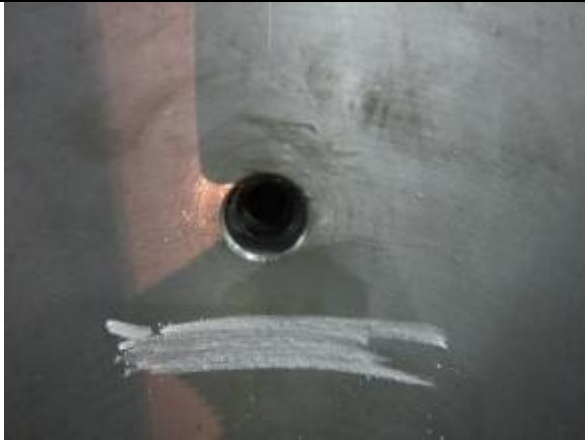
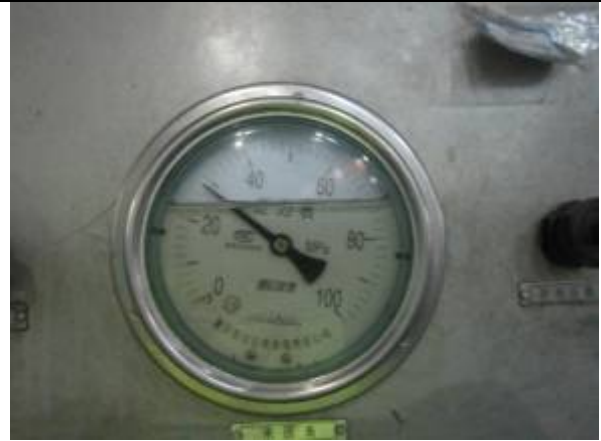
Water seal testing (No leakage)

P=27.5MPa

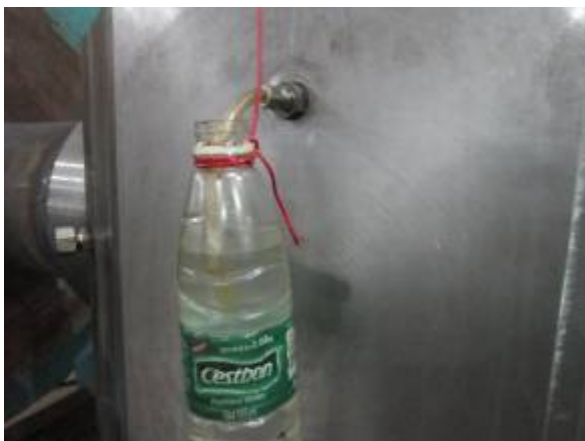
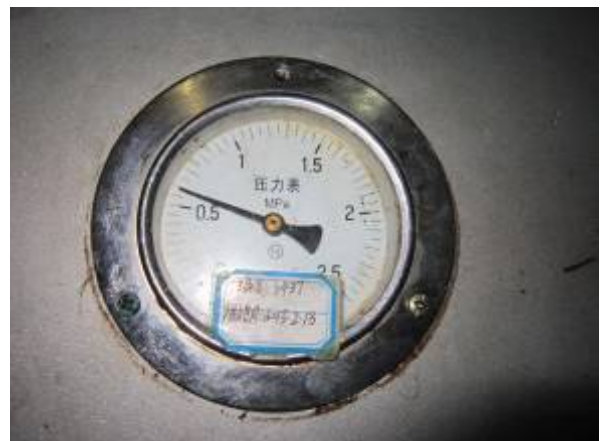
Air seal testing (No leakage)

P=0.6MPa

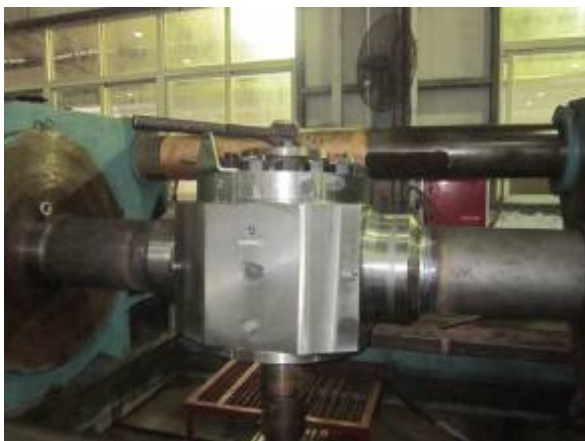
DBB water seal testing (No leakage)

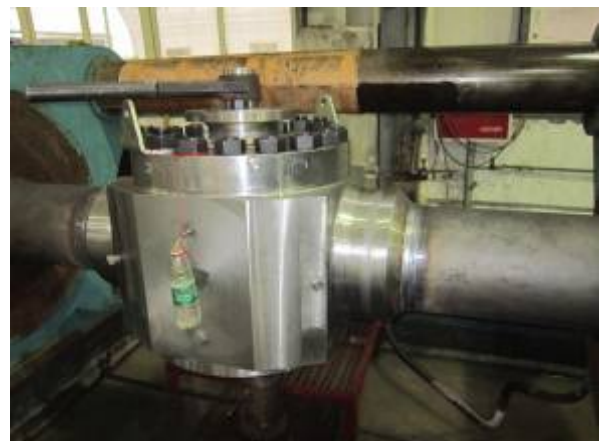
DBB air seal testing (No leakage)

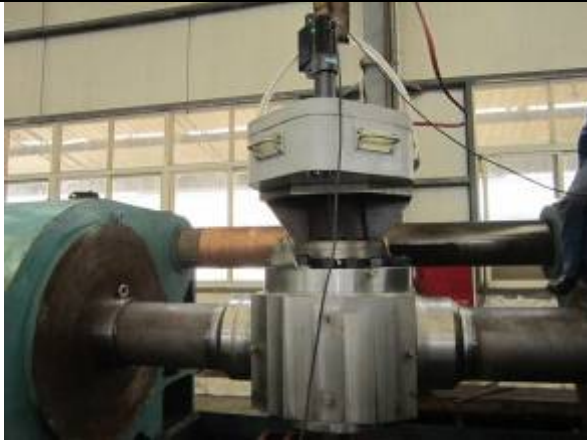
Overview of test torque for item1

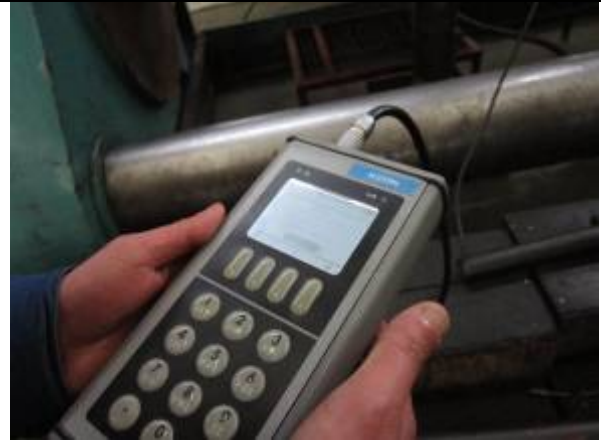
Testing process

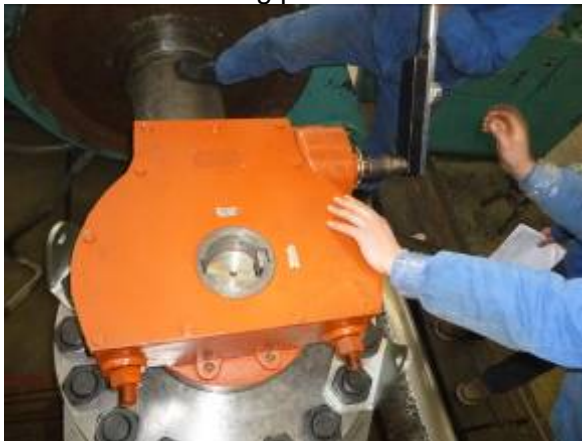
Overview of test torque for item2

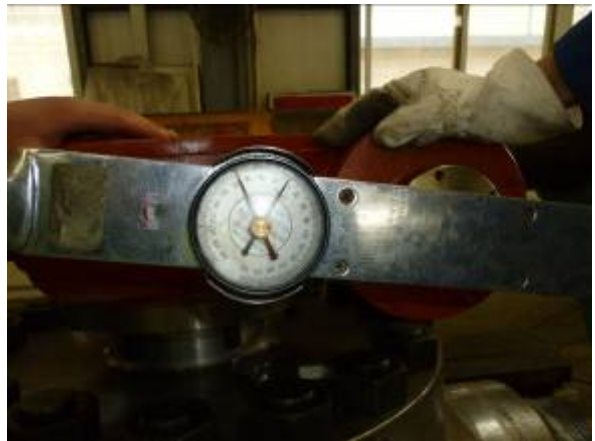
Testing values

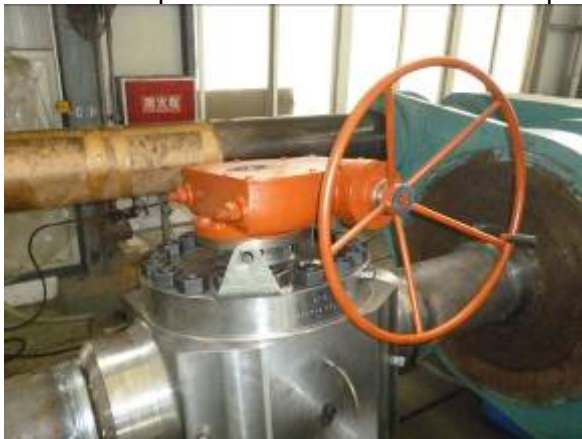
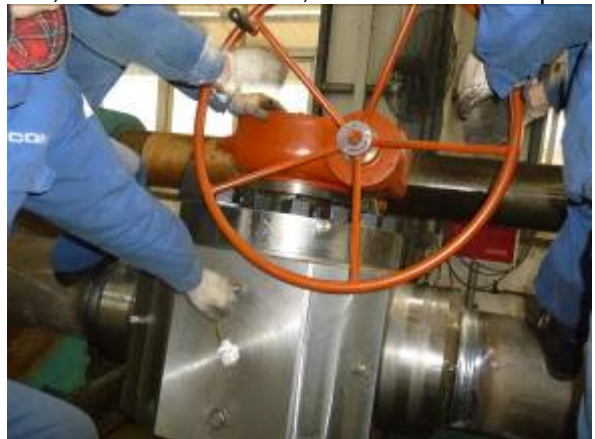
Because the PNEUMATIC ACTUATOR didn't arrive at KCON site (buy it from aboard). So, KCON did the function test with gear box (it's same with itme2). J-PECO inspector witnessed the function process, and run the wheel, it's smooth. Accepted.

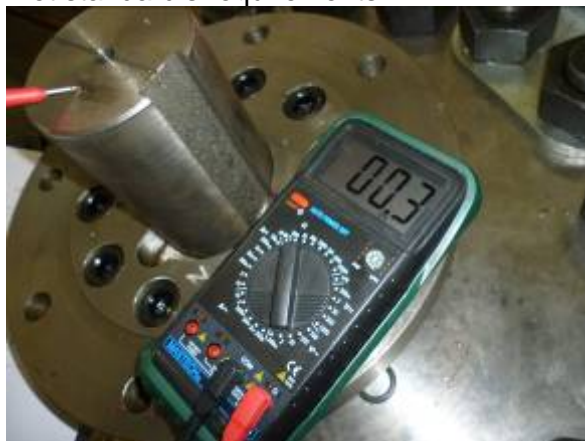
J-PECO inspector witnessed the anti-static testing process. KCON tested the anti-static with multimeter (12V). Required value is less than 10ohm. Actual values are about 0.4ohm, which met standard's requirements.

Between stem and body

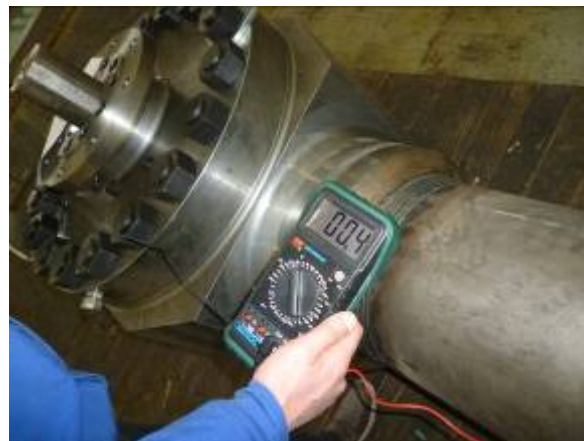
Between stem and ball

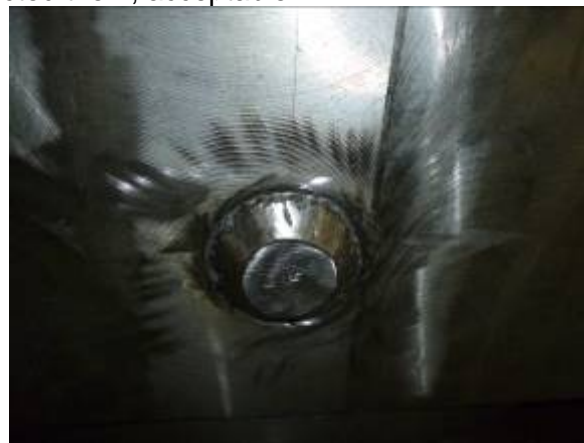
Plugs were welded

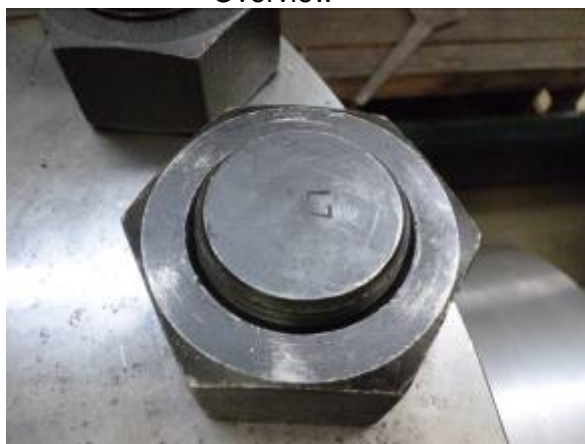
J-PECO inspector checked the Visual quality as per approved drawings and spec. The 2 plugs were welded after pressure testing, it met drawing's requirements. J-PECO inspector found one nut was installed incorrectly. KCON corrected them, acceptable.

Before correcting

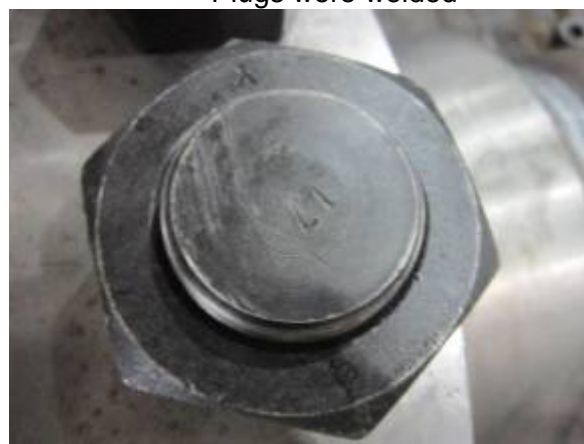
After correcting

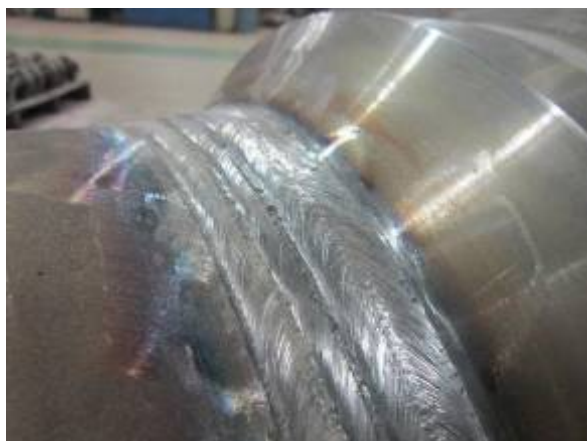
Weld seam check

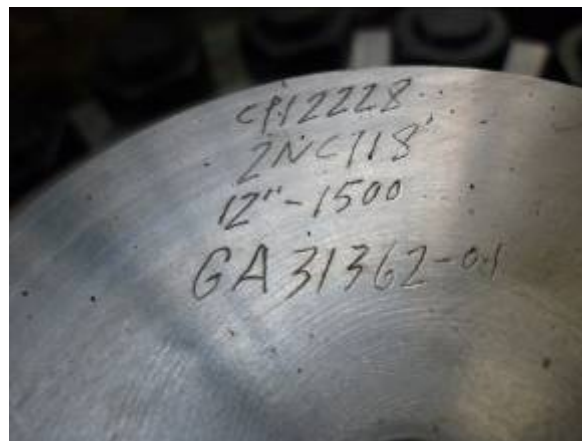
Traceability check

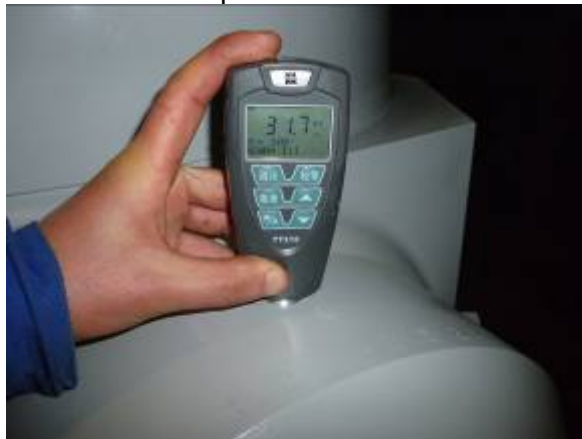
J-PECO inspector randomly checked the dry film thickness for primer.

Check DFT

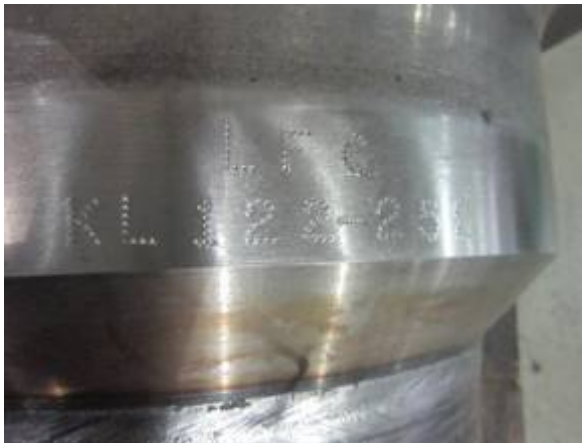
KCON submitted some documents for review.
 J-PECO inspector found the heat number was wrong as per my experience. KCON contacted the forging supplier, and confirmed this thing. And the forging supplier corrected and issued the MTC. KCON corrected the heat number on the surface of parts.

Before correcting

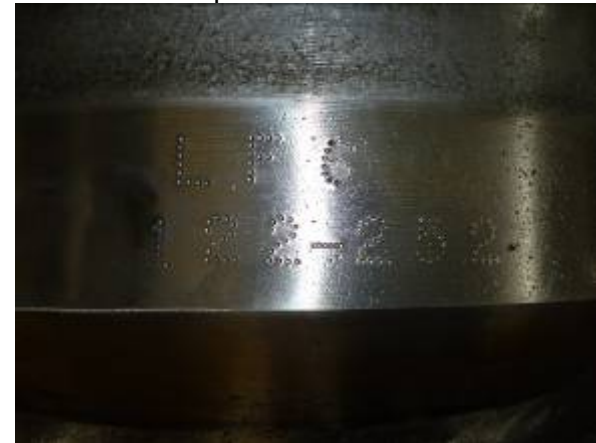
After correcting

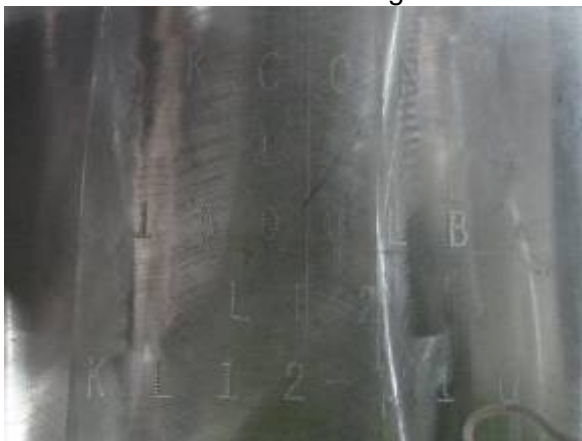
Before correcting

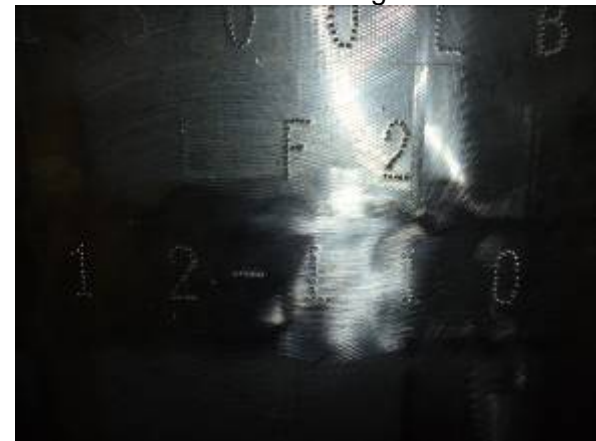
After correcting
