| Industry & Facilities Division<br><br><b>INSPECTION REPORT Nr CLIENT-15210-170510</b> | Page 1/28 |
| <b>J-PECO Job nr: CLIENT-15210-170510</b> | |

| <b>Manufacturer:</b> Zhejiang XXX Pipeline Industry Co., Ltd. | <b>P/o nr:</b> N/A<br>(J-PECO to Manufacturer) |

| No. | SUPPLY /<br>SUBJECT OF INSPECTION | Heat Nr | Manufacturer<br>name | Qty(ea) |
|---|---|---|---|---|
| 1 | Fittings, for details please see annex 1 | / | XXX Pipeline | / |

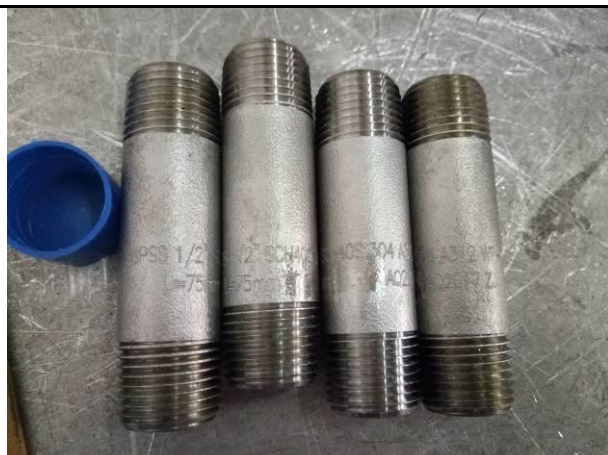
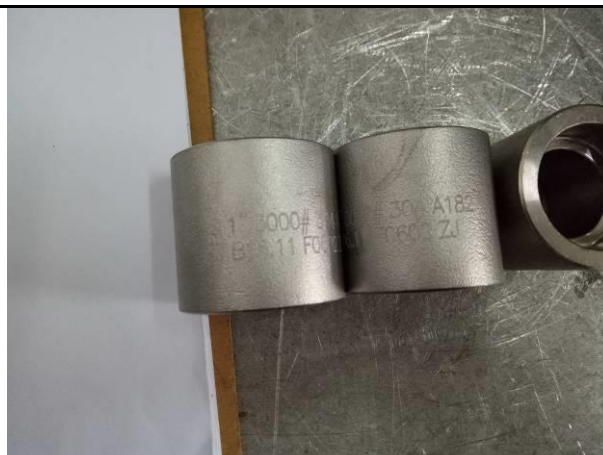
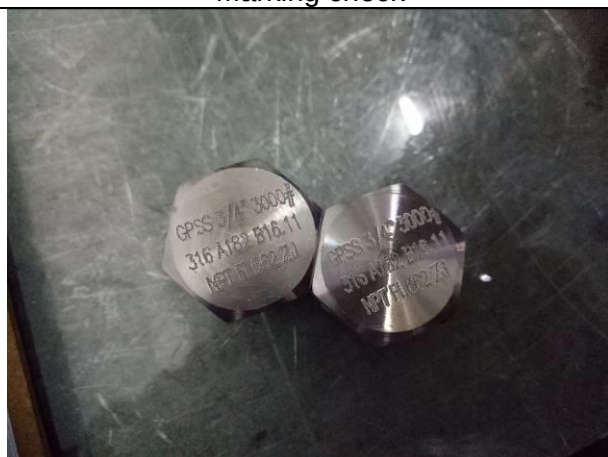
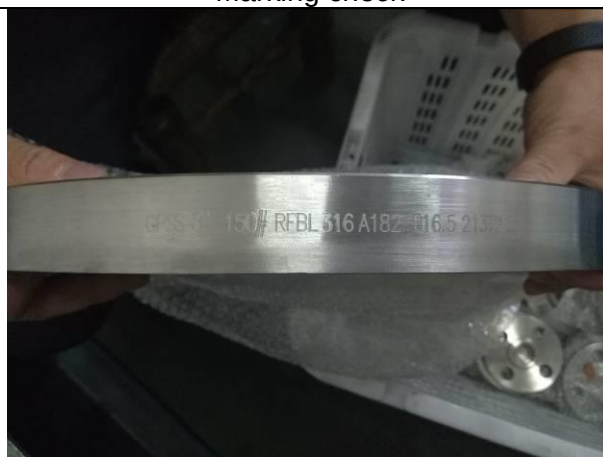
2.1 J-PECO inspector checked the fitting and pipe markings according to order requirement, details as following:

Marking check

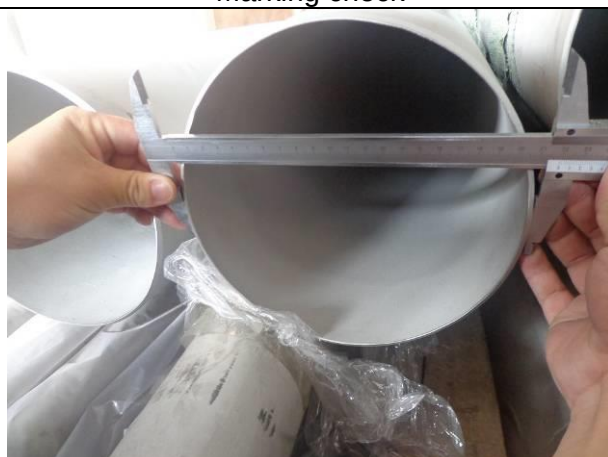
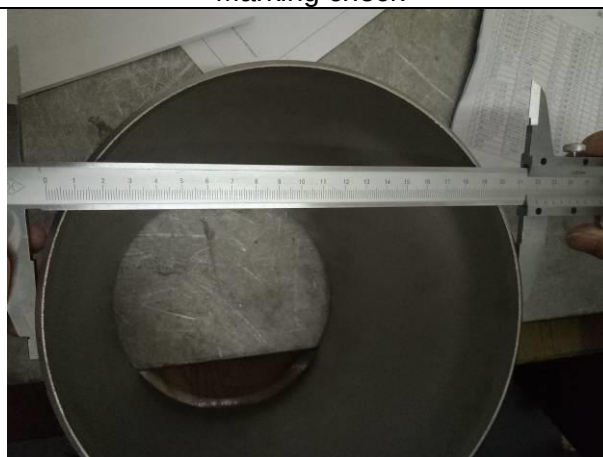
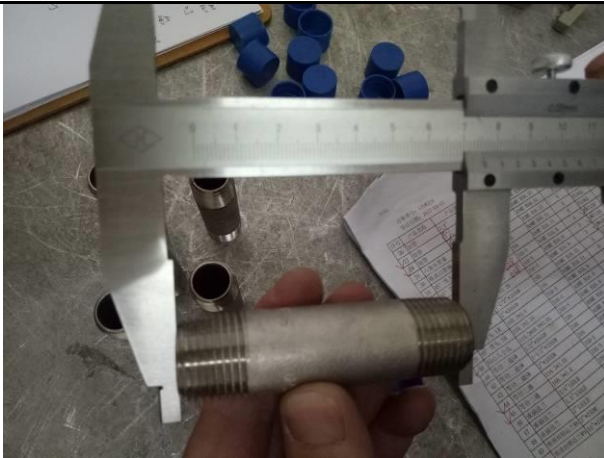
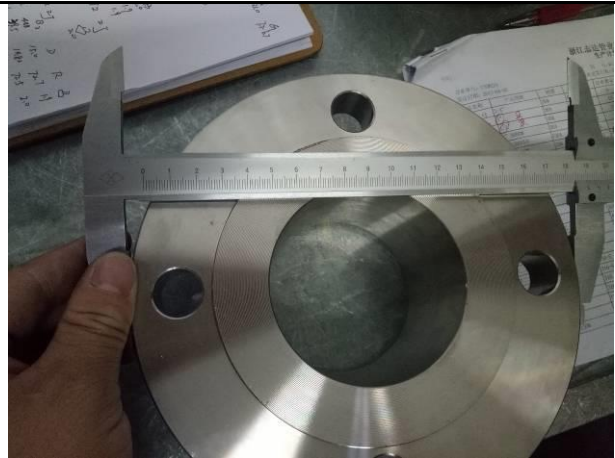
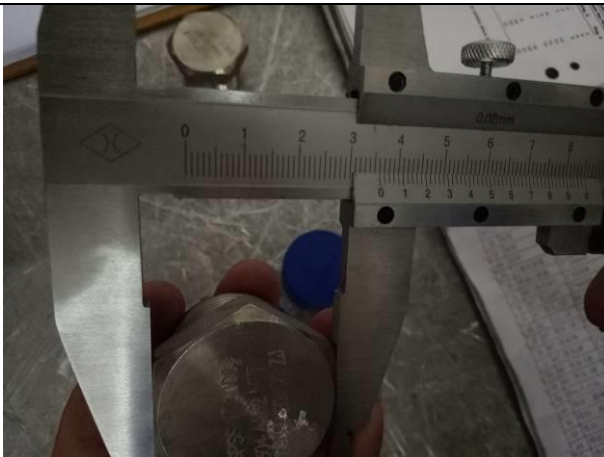
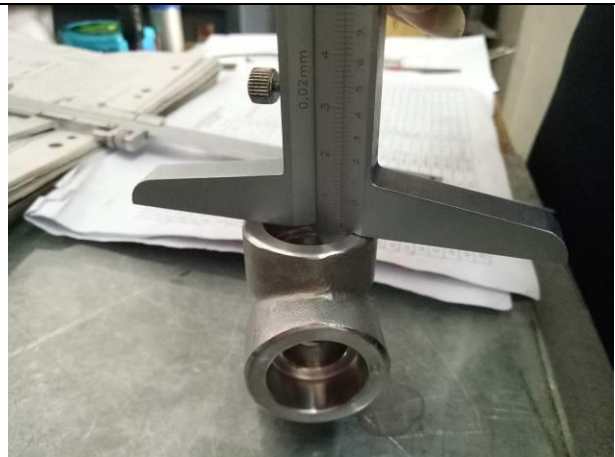
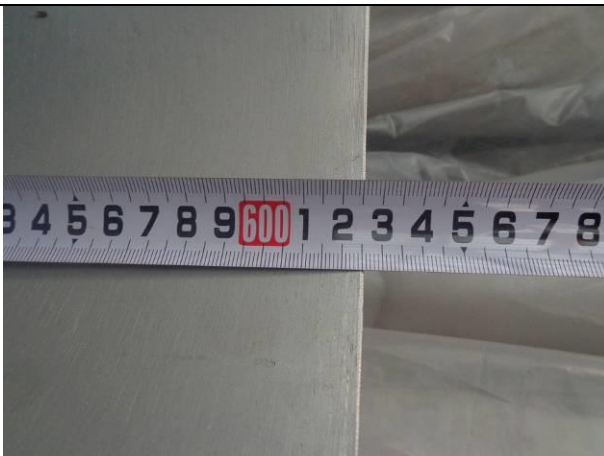
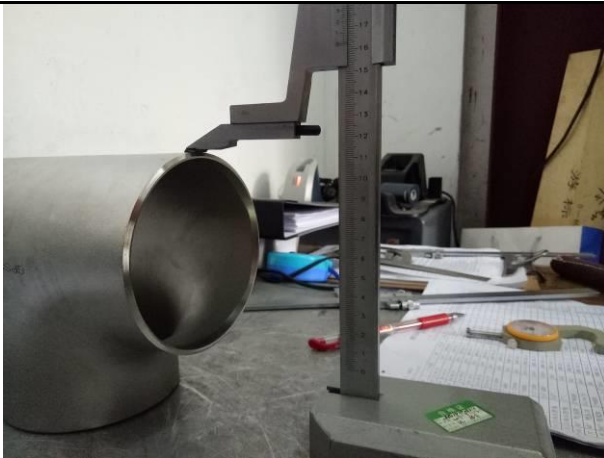
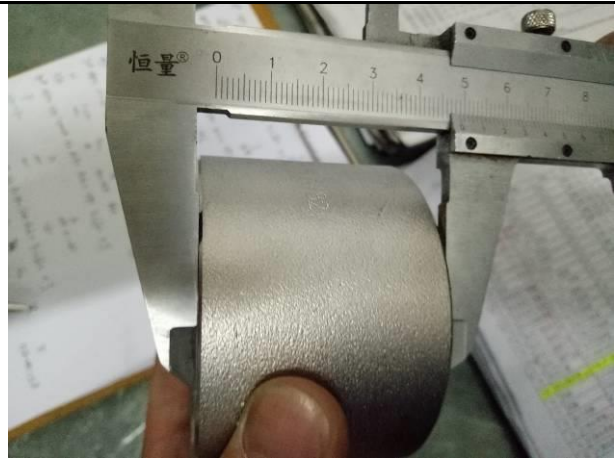
2.2 J-PECO inspector performed dimension check of the fittings and pipes by random sampling of 30% of each item. The inspection result met the requirement of The relevant

Dimension check

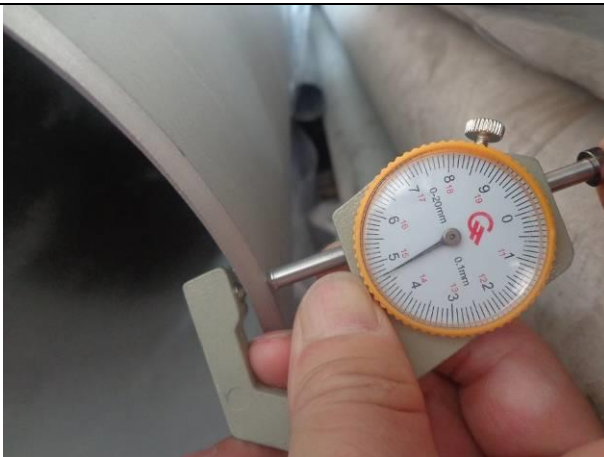
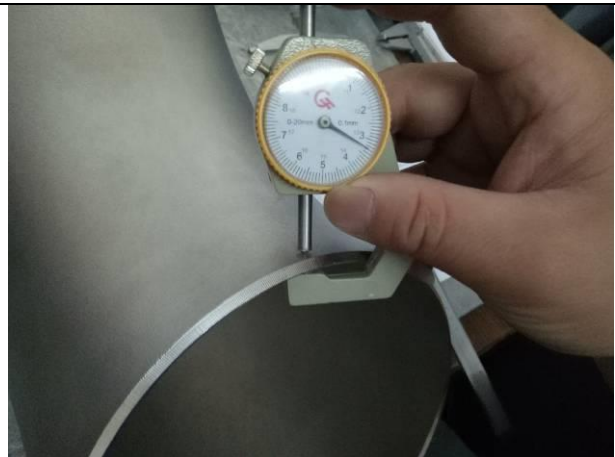
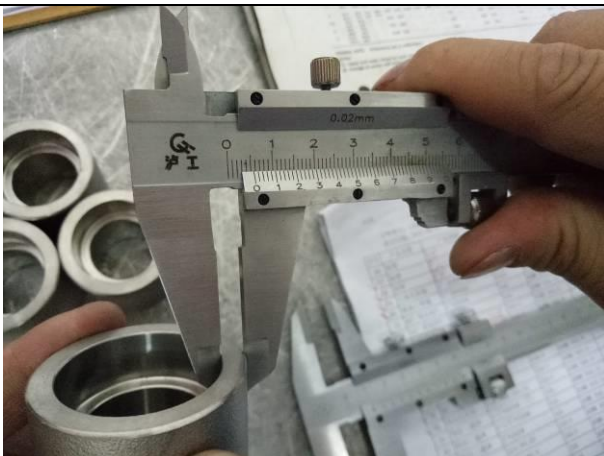
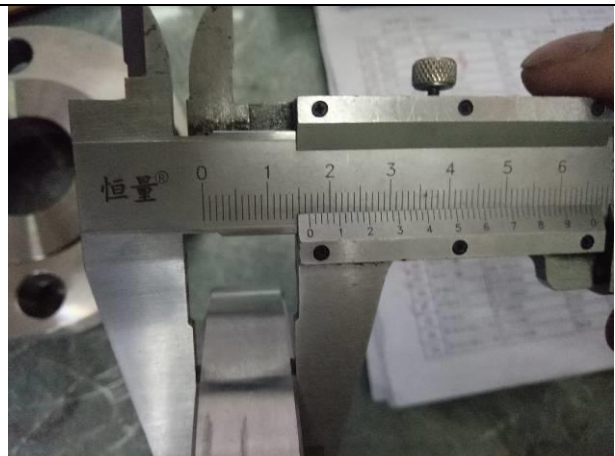
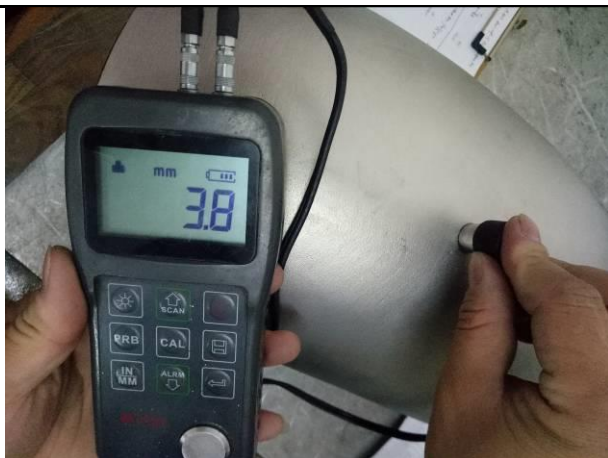
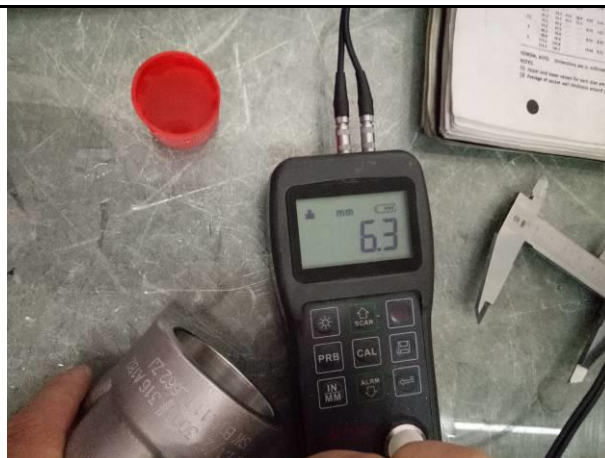
Thickness check

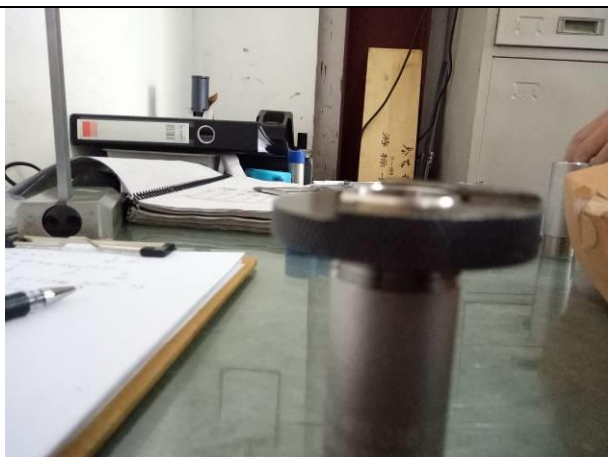
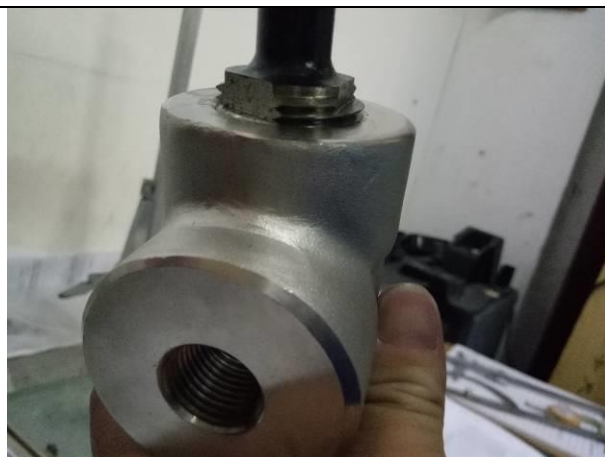
NPT Check

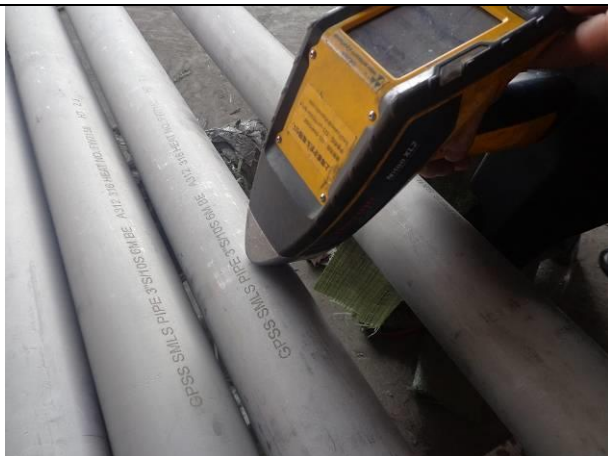
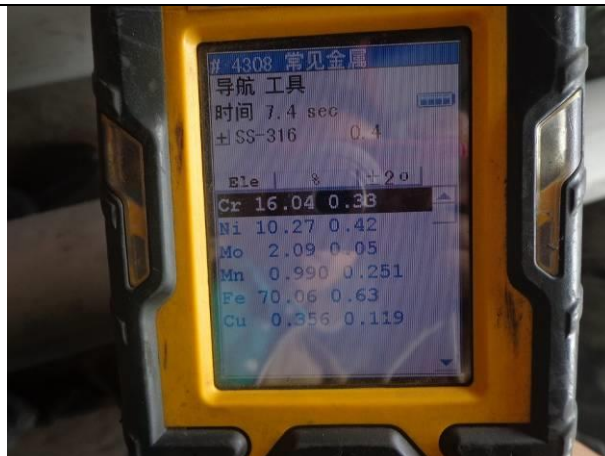
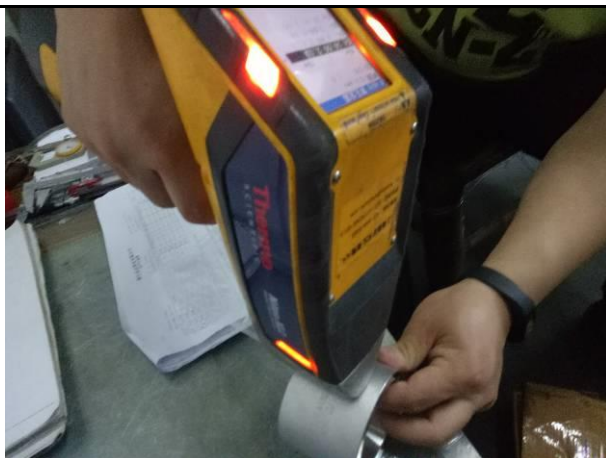
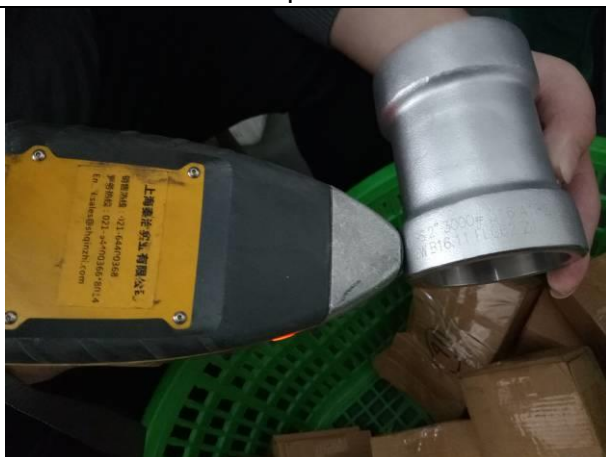
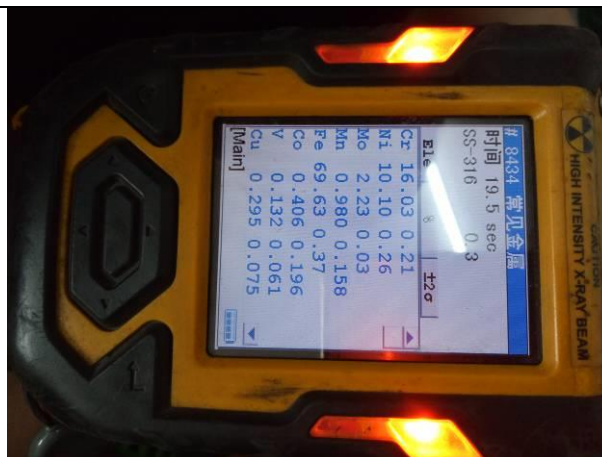
2.3 J-PECO inspector witnessed PMI of the pipes by random sampling of 10%. PMI only showed the metallic element and the inspection result met the requirement of the relevant standard. Details inspection data see the following annex 2.

Note: 1. Portable PMI test was not suitable for material A105 and A106.

2. PMI test failed of Item 31 and 34, now in re-manufacturing.

PMI process

PMI test result

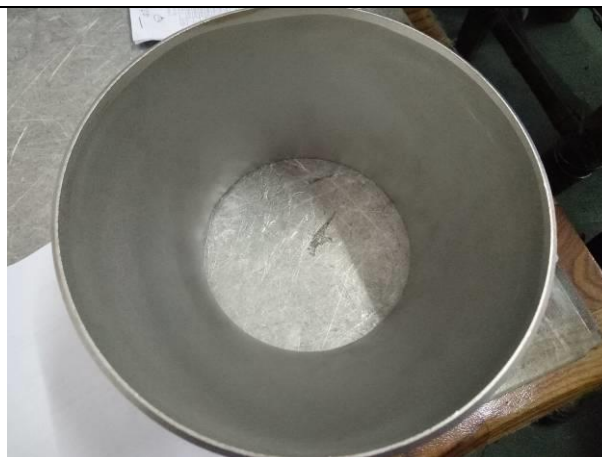
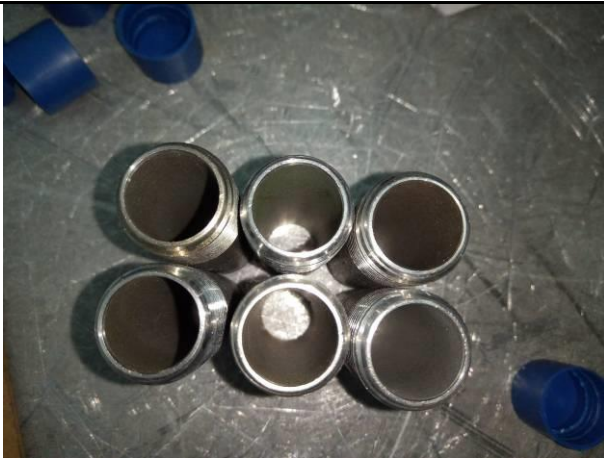
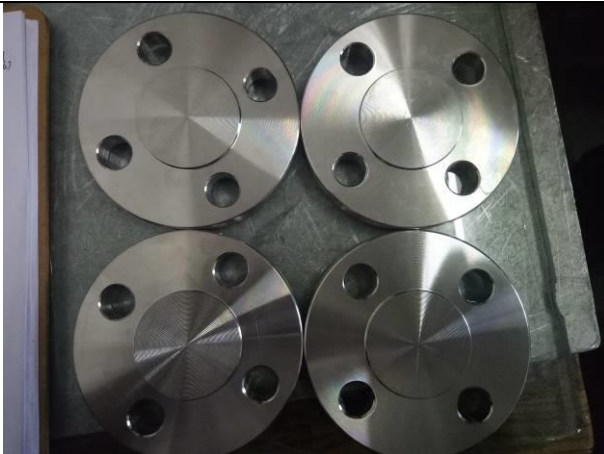
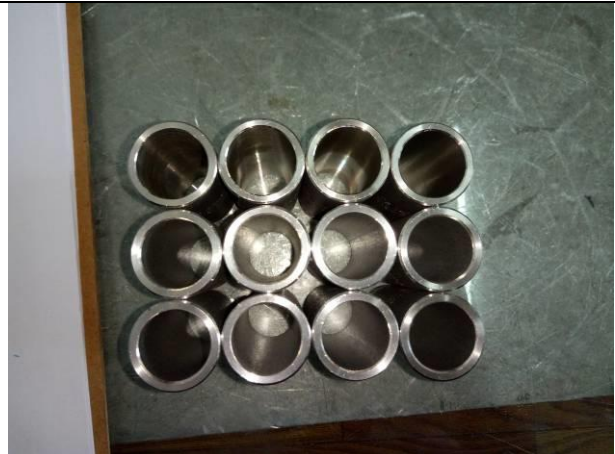
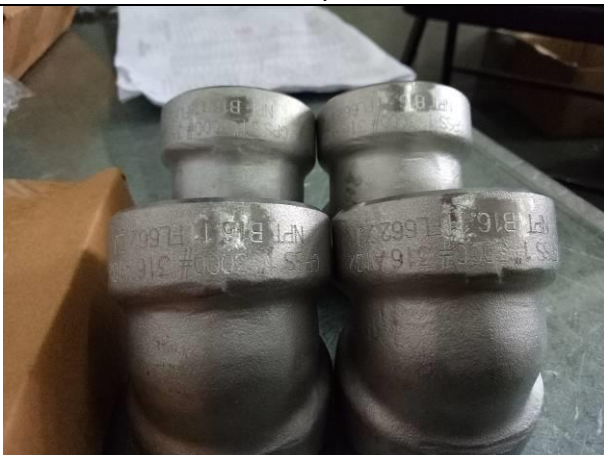
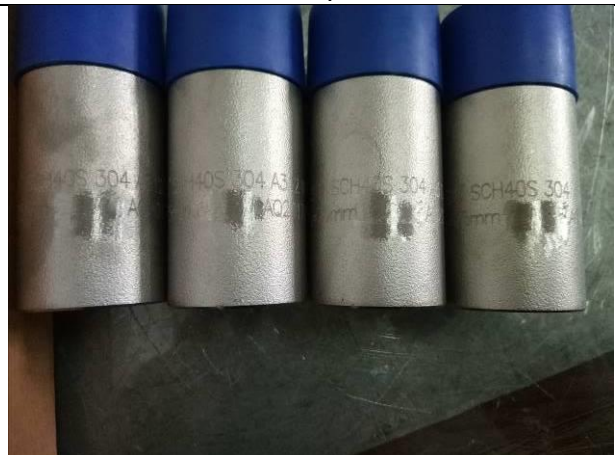
2.4 J-PECO inspector performed 100% visual inspection of the fittings and pipes. The appearance of the most fittings and pipes were smooth and without unacceptable defects. The inspection result was in accordance with CLIENT requirement except for **there were some grinding markings on stencil areas of item 16, 17,18,29,30,31,32,33 and 35, cracks in interior surface of item 59 then rejected. Item 74, actual products were not conformed to PO requires, mill replies they were confirming with GPS now.**

Visual inspection

Rejected due to inner surface cracks
