INSPECTION REPORT Nr LNP/BJ-12/048-CD01

PROJECT: Ghana Early Phase Gas Infrastructure Project	Ref: JPP/HF-12/048
J-PECO Client: Sinopec International Petroleum Service Company (SIPSC)	P/o nr: / (client to J-PECO)
Manufacturer: SICHUAN KEYCON VALVE MANUFACTURING CO., LTD (KCON)	P/o nr: / (client to Manufacturer)
Inspection requested by: Sinopec International Petroleum Service Company (SIPSC)

No.	SUPPLY / SUBJECT OF INSPECTION	KCON Serial Nr	Project TAG Nr	QTY
1	12"-1500LB Top Entry Trunnion Ball Valves (PNEUMATIC ACTUATOR)	J-31362-1	ESDV-01-001-GP	1 set
2	12"-1500LB Top Entry Trunnion Ball Valves (GEAR OPERATOR)	J-31361-1, J-31361-2, J-31361-3, J-31361-4.	J-PECO-01-001-GP, J-PECO-01-002-GP, J-PECO-01-003-GP, J-PECO-01-004-GP.	4 sets

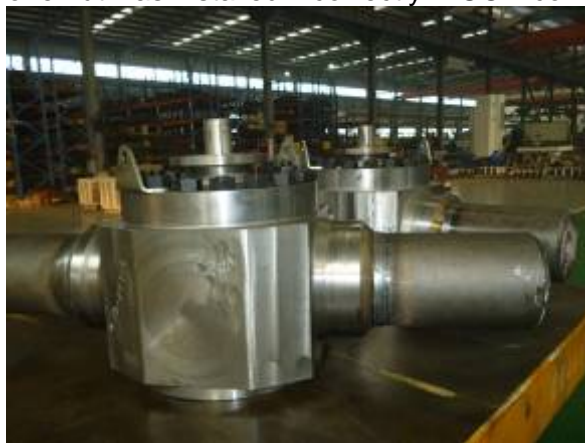
Overview

J-PECO inspector checked the Visual quality as per approved drawings and spec. The 2 plugs were welded after pressure testing, it met drawing's requirements. J-PECO inspector found one nut was installed incorrectly. KCON corrected them, acceptable.

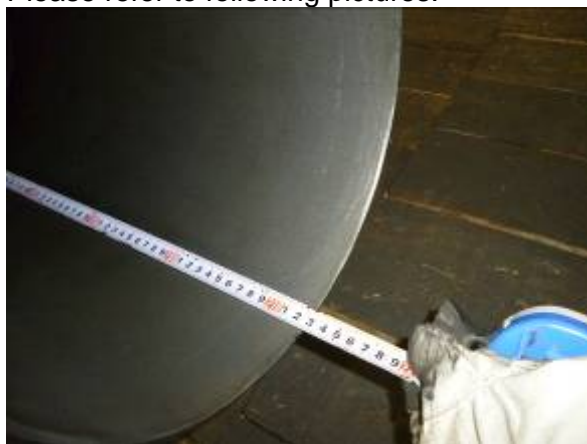
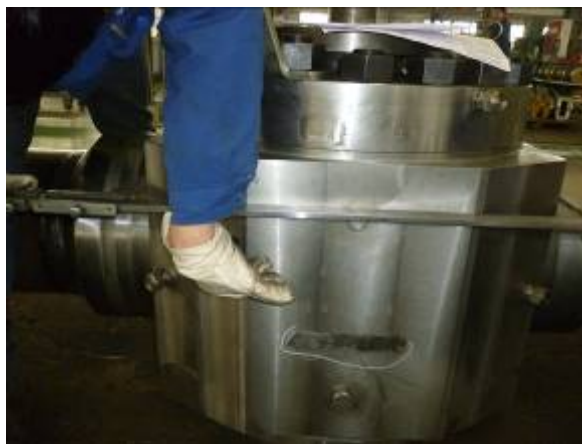
J-PECO inspector checked the main dimension as per approved drawings. It's acceptable. Please refer to following pictures.

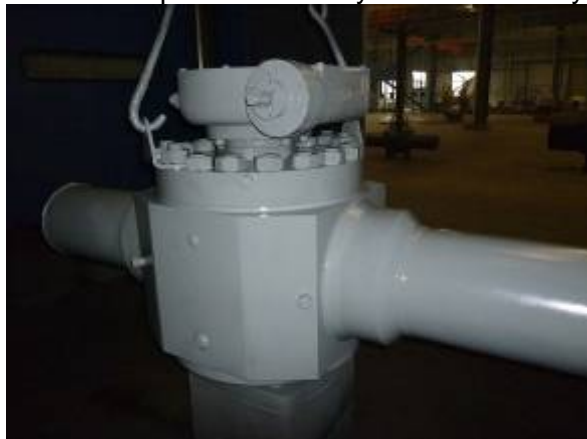
Overview

J-PECO inspector randomly checked the dry film thickness for primer.

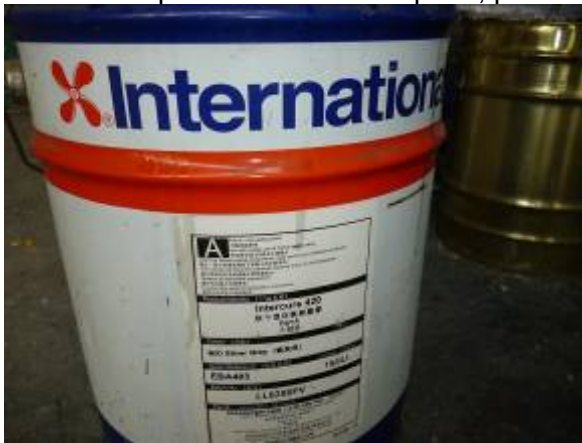
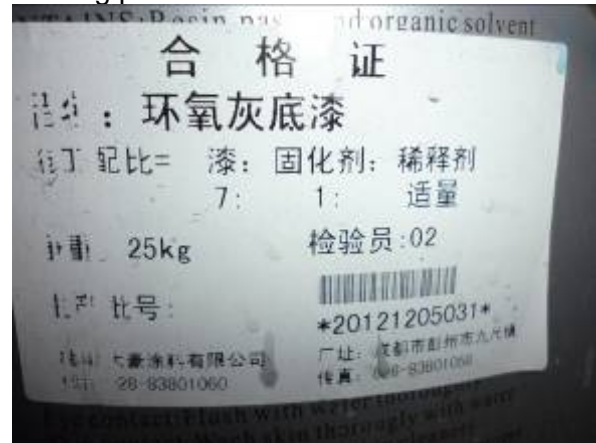
KCON do the painting as per KCON' specification. And DFT met KCON's procedure. KCON didn't complete top coat till J-PECO inspector leave.
 J-PECO inspector checked the paint, please following pictures.
